Manhole Inspection Summary

Manhole # S71K__003MH

Insp Date: **5/13/08 10:26 AM**

Location Address: **6725 O'Donnell St.**

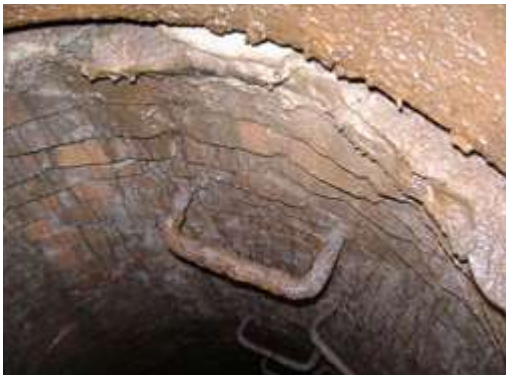
Defect 3

Condition: ☐ Sound ☐ Cracked ☐ Root Intrusion ☒ **Loose Brick** ☒ **Deteriorated**

Infiltration: ☐ None ☒ **Joint** ☐ Cracks ☒ **Mortar** ☐ Roots ☐ Wall

infiltration evidence in chimney

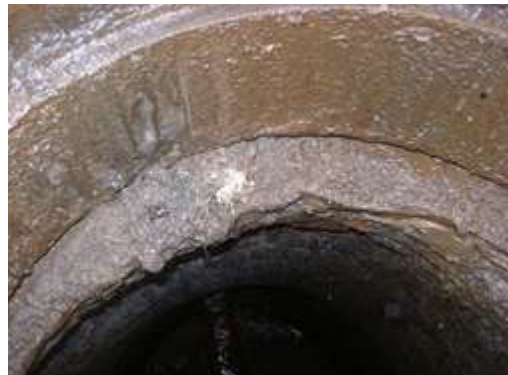
Defect 1

Offset: **3** (in.)

frame offset

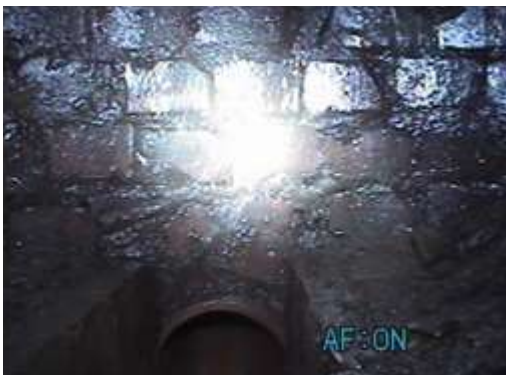
Defect 4

Infiltration: ☐ None ☐ Joint ☐ Cracks ☒ **Mortar** ☐ Roots ☐ Wall

Infiltration in barrel wall

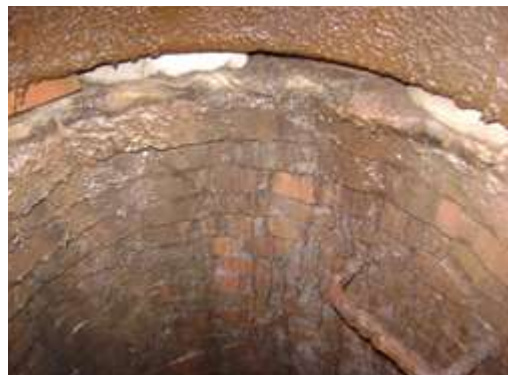
Defect 2

loose mortar under frame

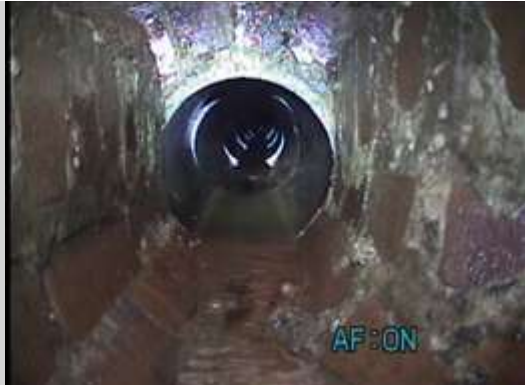
12 O'Clock Outflow

Pipe Height: **8.4** (in.) Rod and Bar (Angled)
Pipe Material: **Clay** ☐ Pipe Lined
Invert Depth: **10.08** (ft.) Flow Characteristics: **Slow**
Deposits: ☒ None ☐ Mud ☐ Sludge ☐ Debris ☐ Grease
Silt Depth: (in.) Deposits Extent:
Infiltration: **None** Pipe Seal Cond: **Sound**

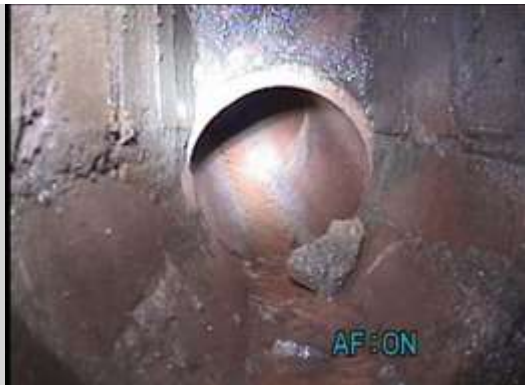
3 O'Clock Inflow

Pipe Height: **6** (in.) Rod and Bar (Angled)
Pipe Material: **Clay** ☐ Pipe Lined
Invert Depth: **10.00** (ft.) Flow Characteristics: **Slow**
Deposits: ☒ None ☐ Mud ☐ Sludge ☐ Debris ☐ Grease
Silt Depth: (in.) Deposits Extent:
Infiltration: **None** Pipe Seal Cond: **Sound**

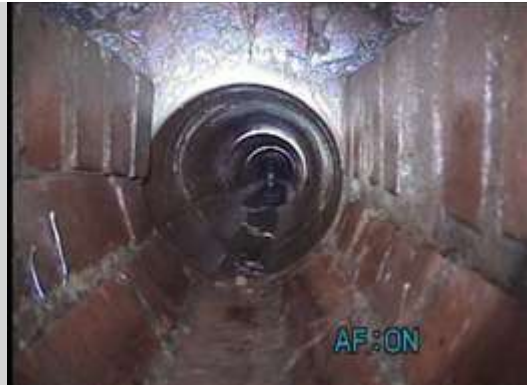
6 O'Clock Inflow

Infiltration: **None** Pipe Seal Cond: **Sound**
